## **Memorandum**

*Subject: 2010 Libby Public Schools Investigation Plan*

During previous investigations, vermiculite was identified within isolated areas at several of the public schools within Libby. As a result, CDM Federal Programs Corporation (CDM) was tasked to complete a full detailed investigation (DI) at the five major public schools in Libby: Libby High School (150 Education Way), Libby Middle School (101 Ski Rd), Libby Elementary School (700 Idaho Ave), Kootenai Valley Head Start (247 Indian Head Rd), and the Administrative Building (724 Louisiana Ave).

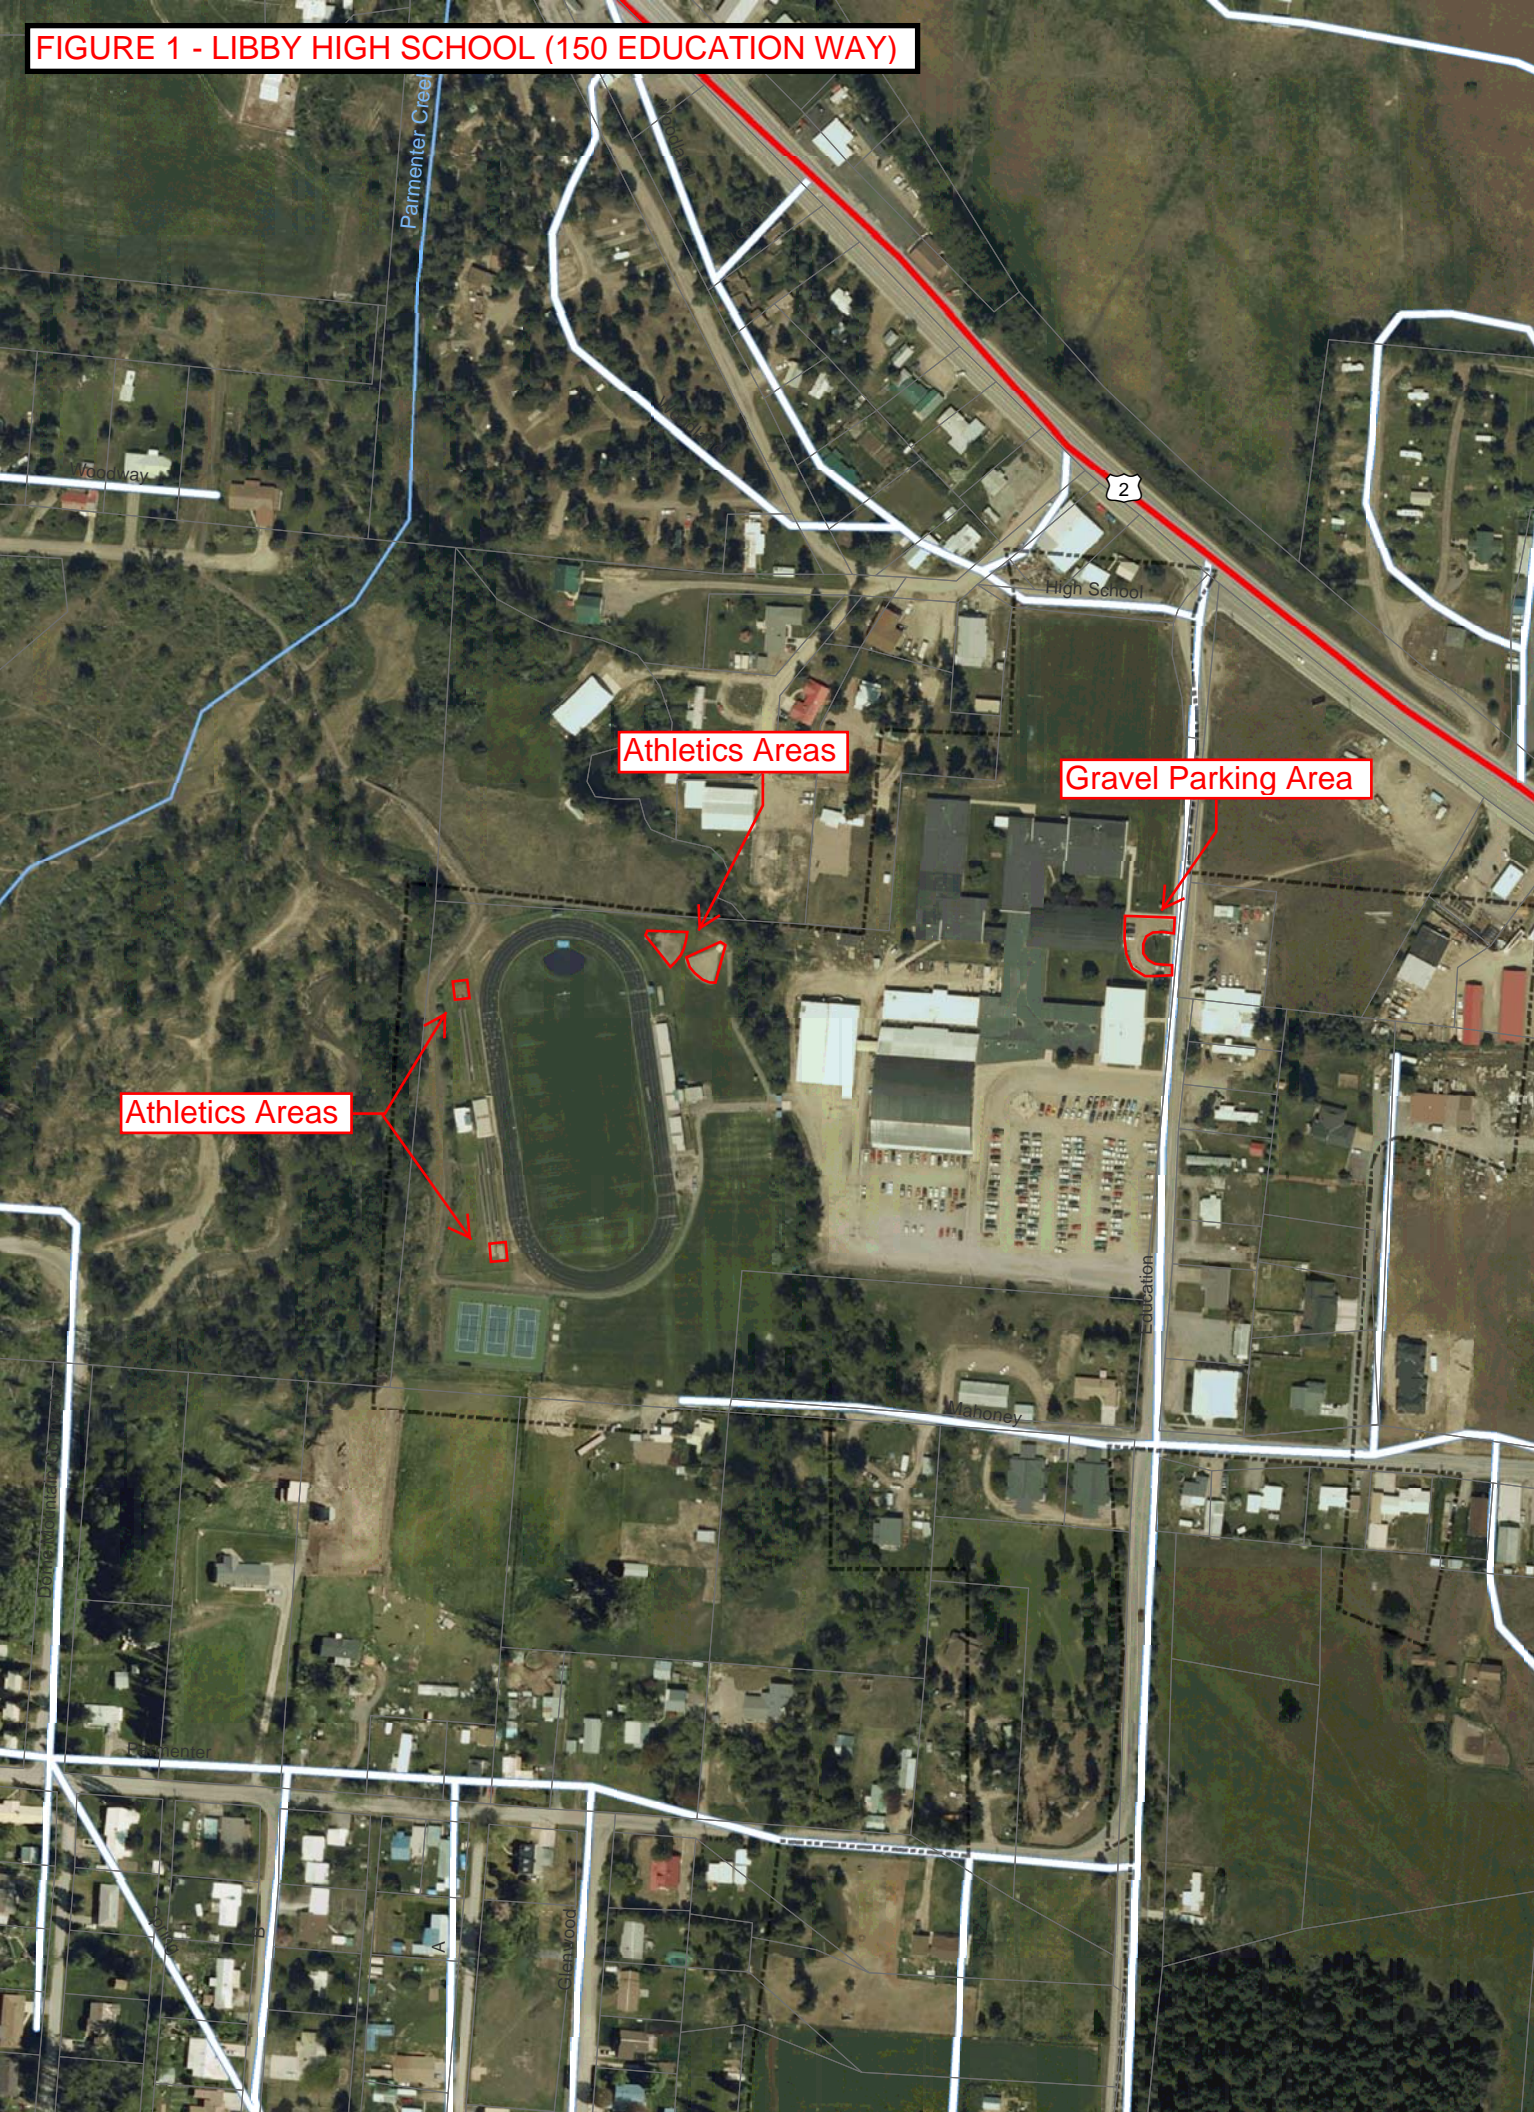
FIGURE 1 - LIBBY HIGH SCHOOL (150 EDUCATION WAY)

The first phase of investigation activities will be limited to a visual inspection of the soils within traditional SUAs (e.g., driveways, parking areas, flowerbeds, planters, and defined play areas). Figures 1 through 5 indicate known SUAs that will be inspected. The

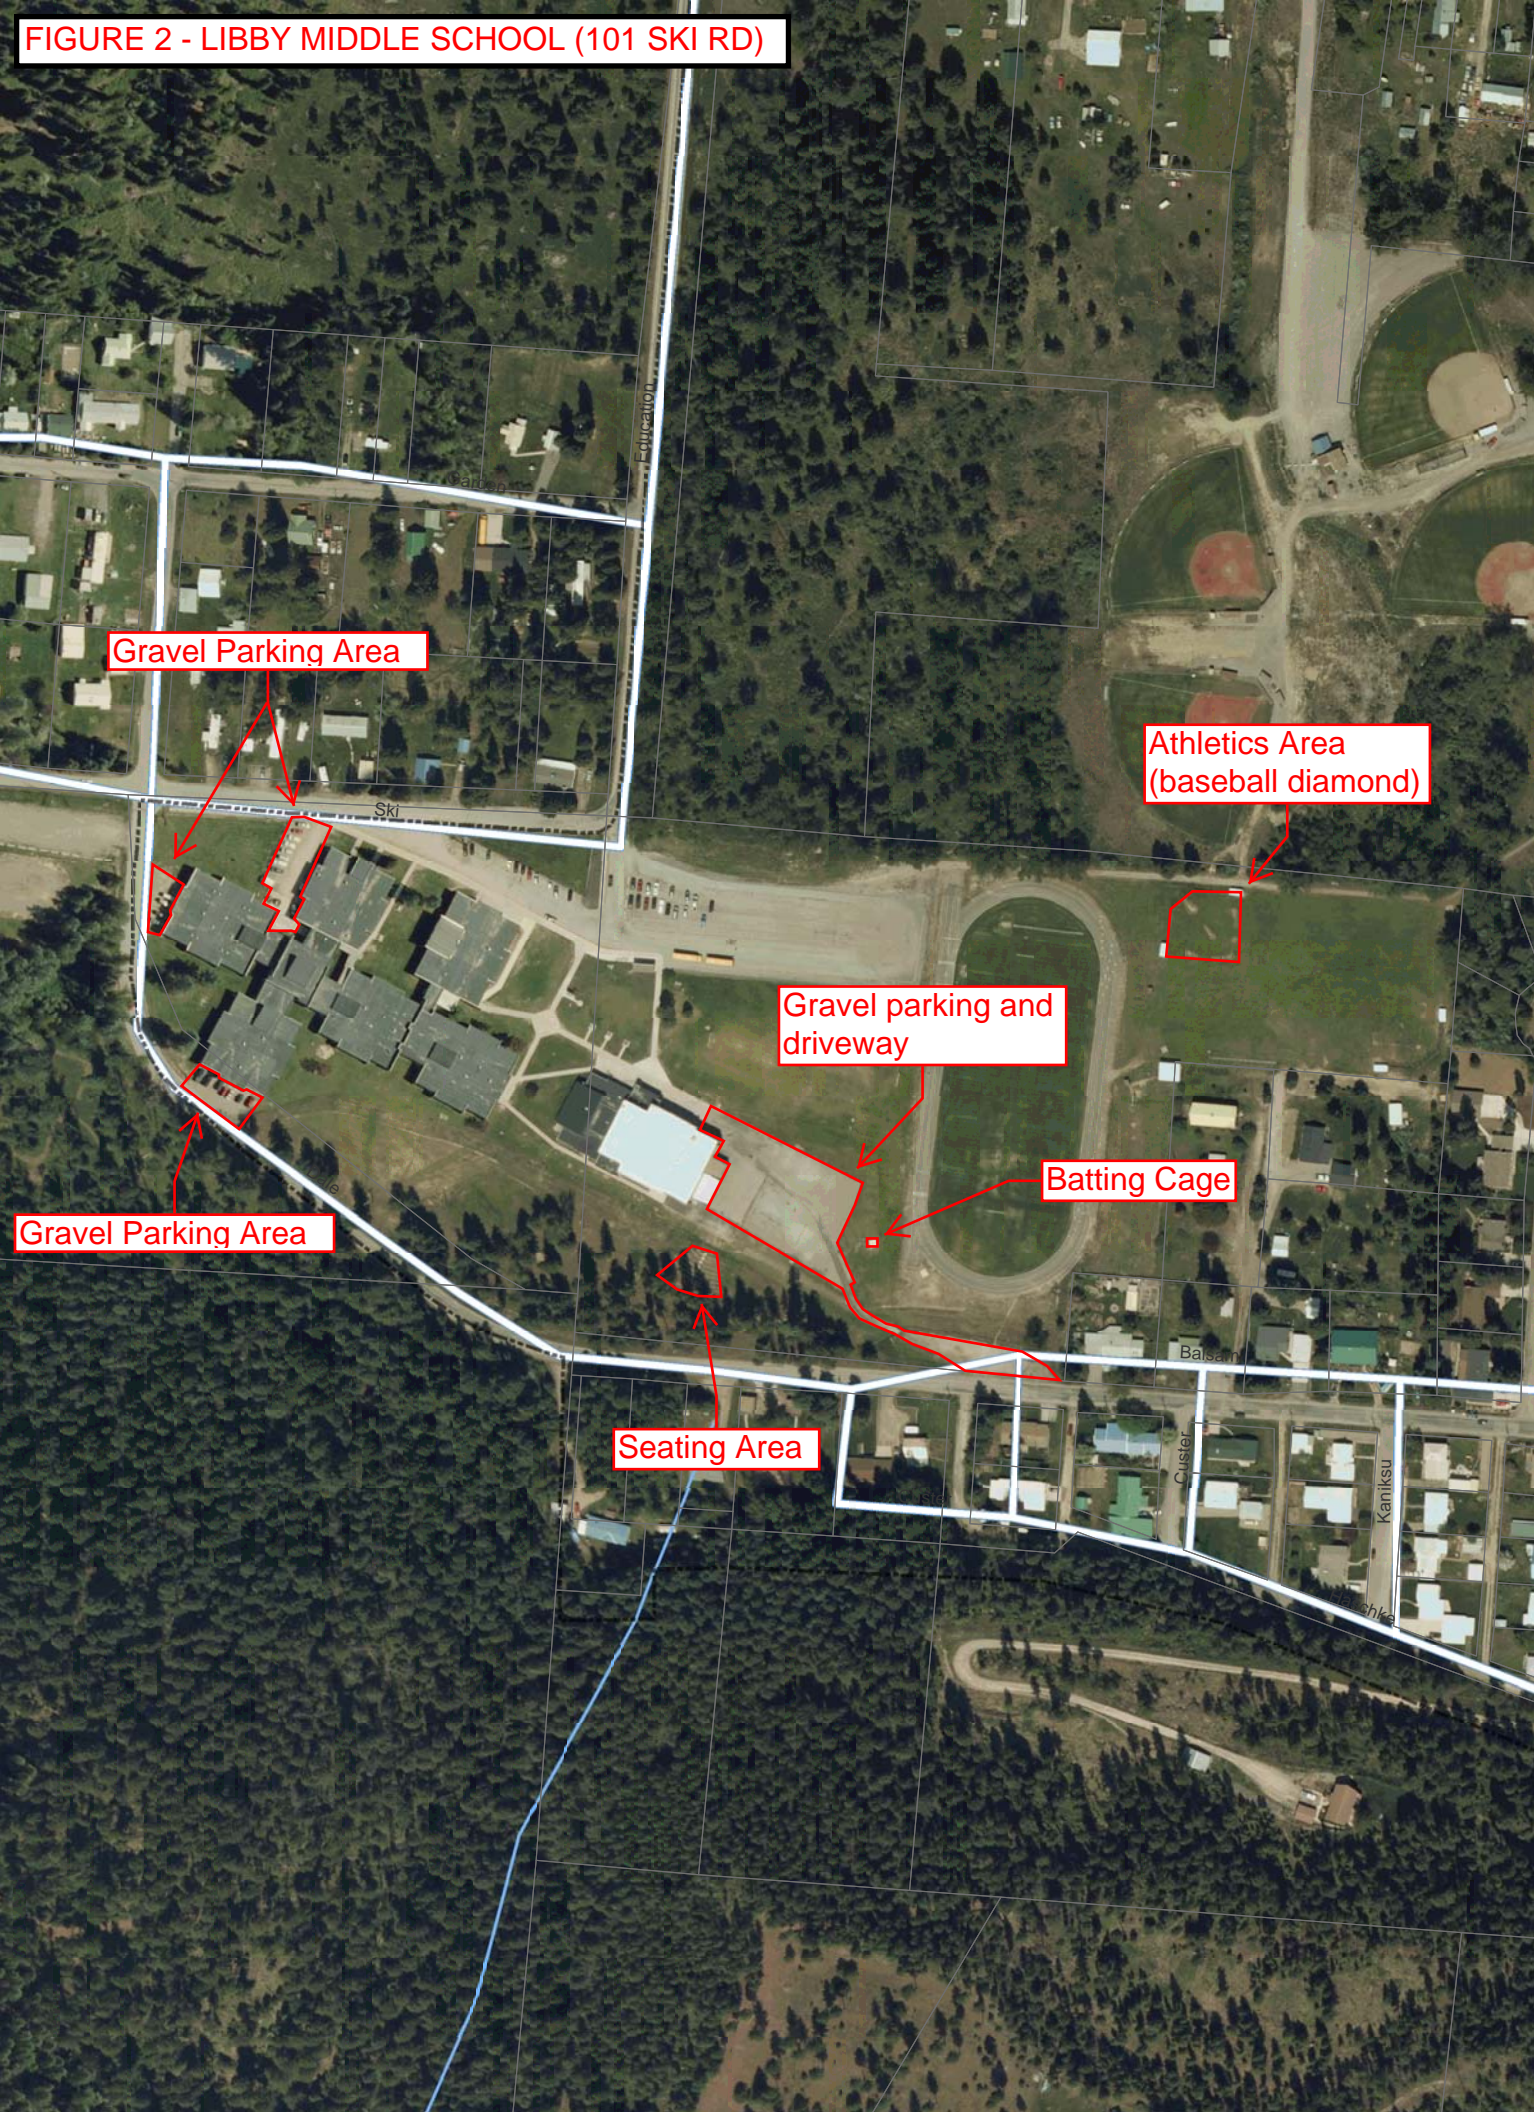
FIGURE 2 - LIBBY MIDDLE SCHOOL (101 SKI RD)

Gravel Parking Area

Athletics Area  
(baseball diamond)

Gravel parking and  
driveway

Batting Cage

Seating Area

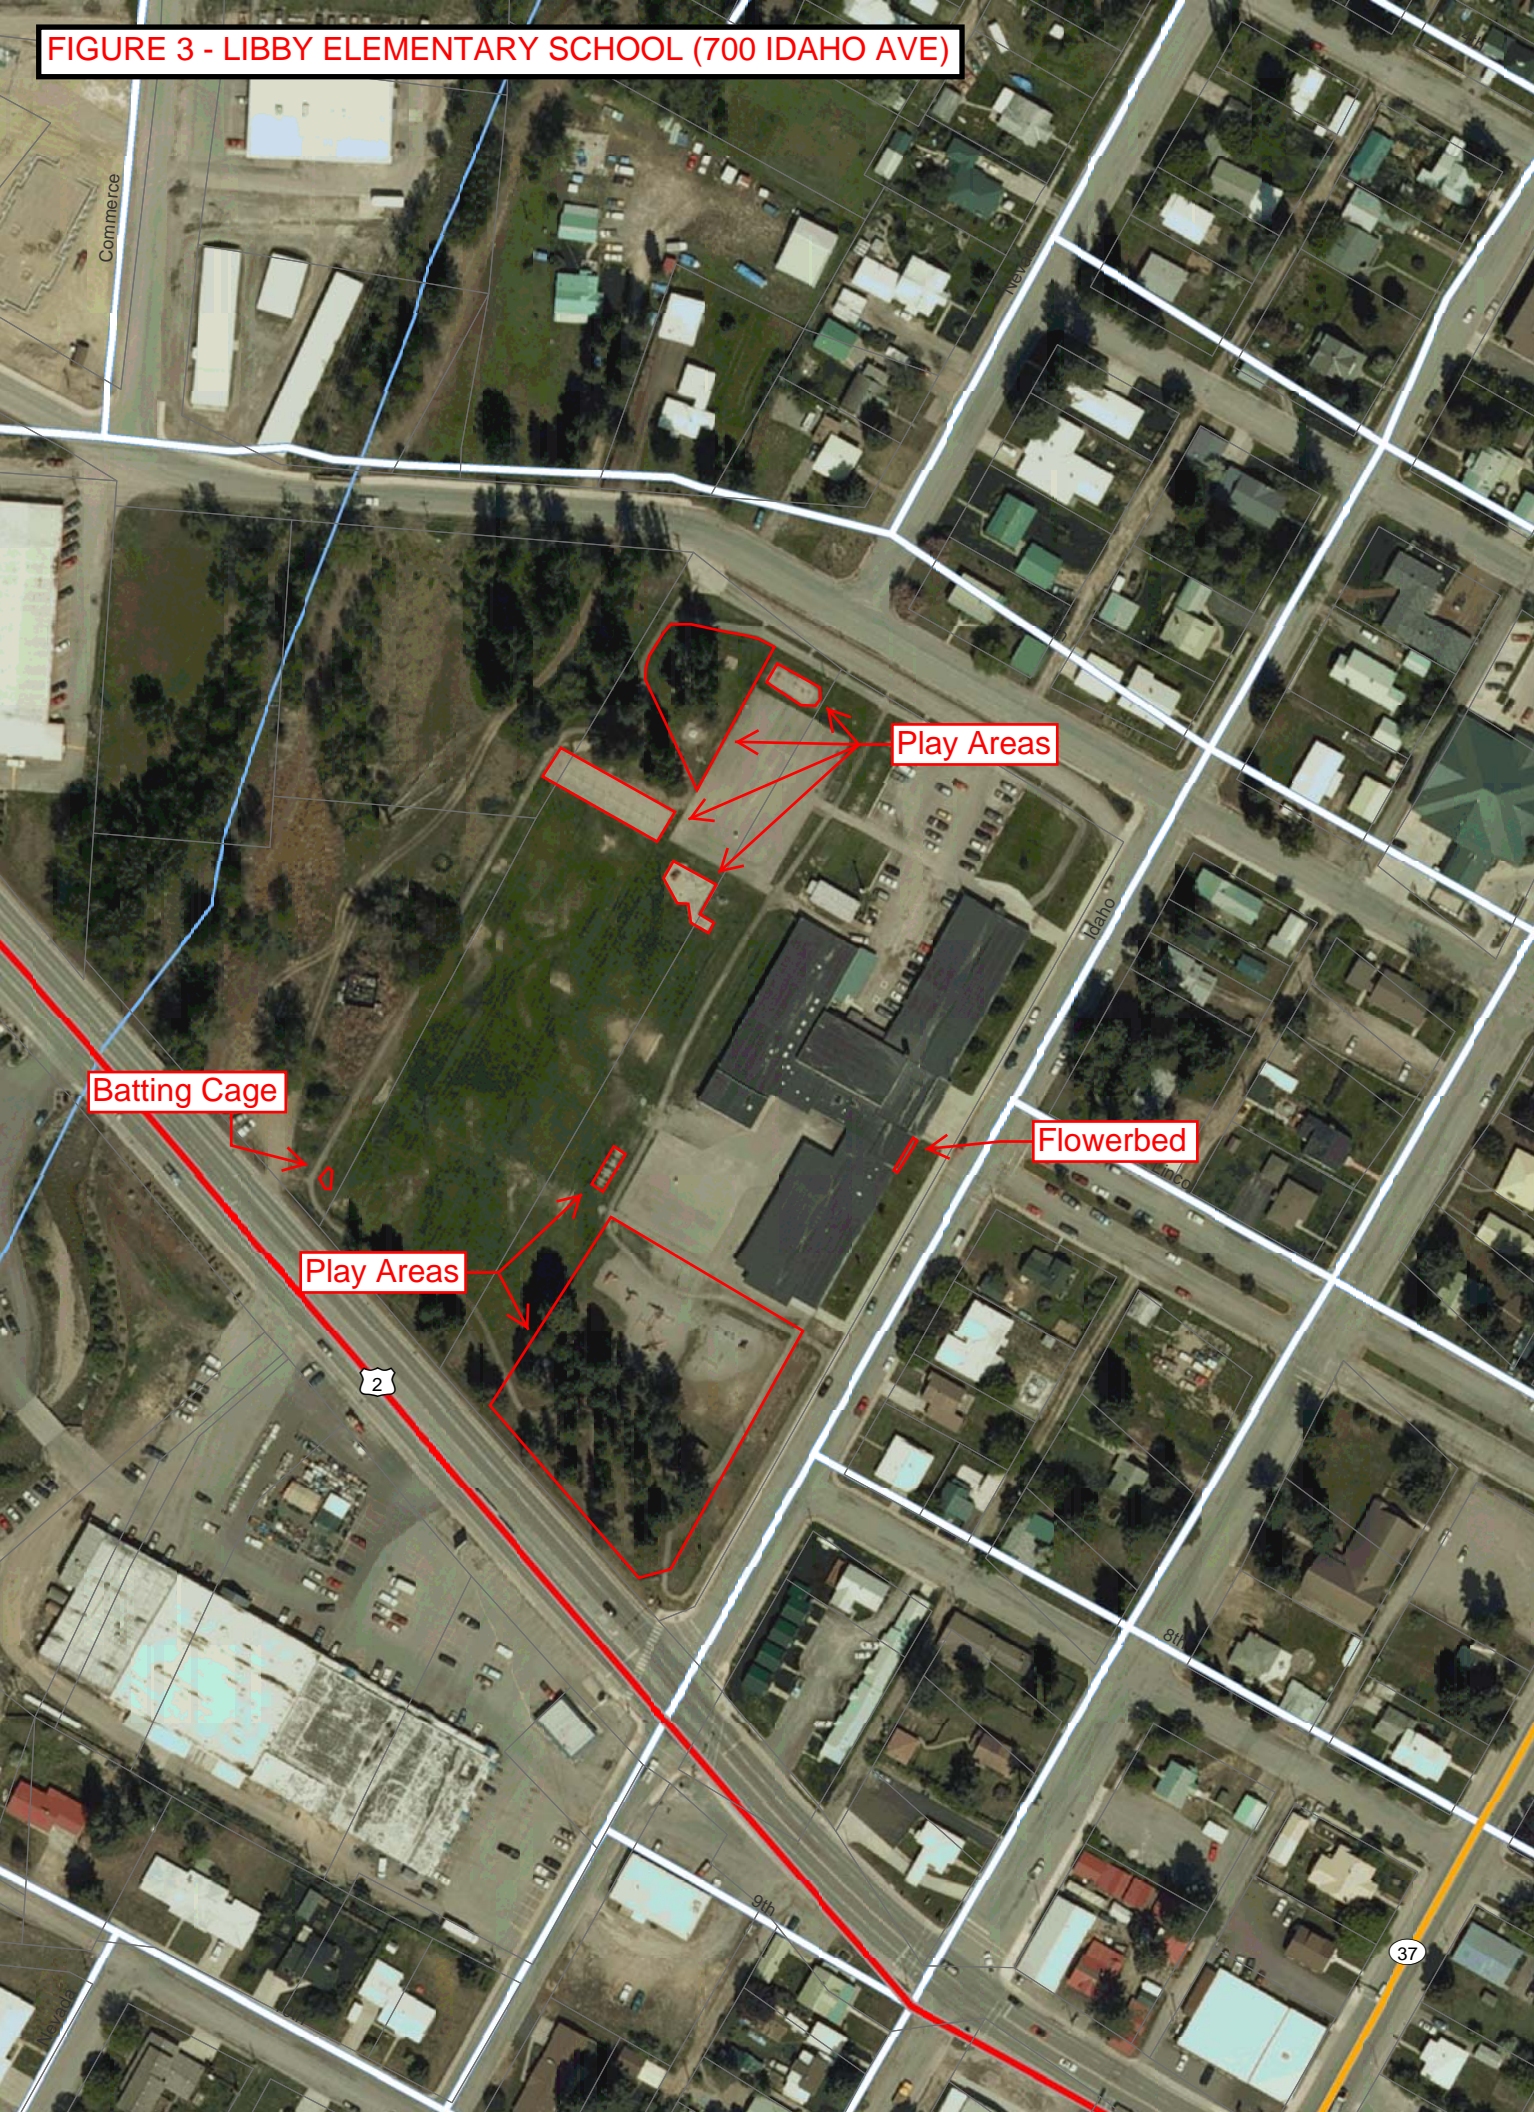
FIGURE 3 - LIBBY ELEMENTARY SCHOOL (700 IDAHO AVE)

Batting Cage

Play Areas

Flowerbed

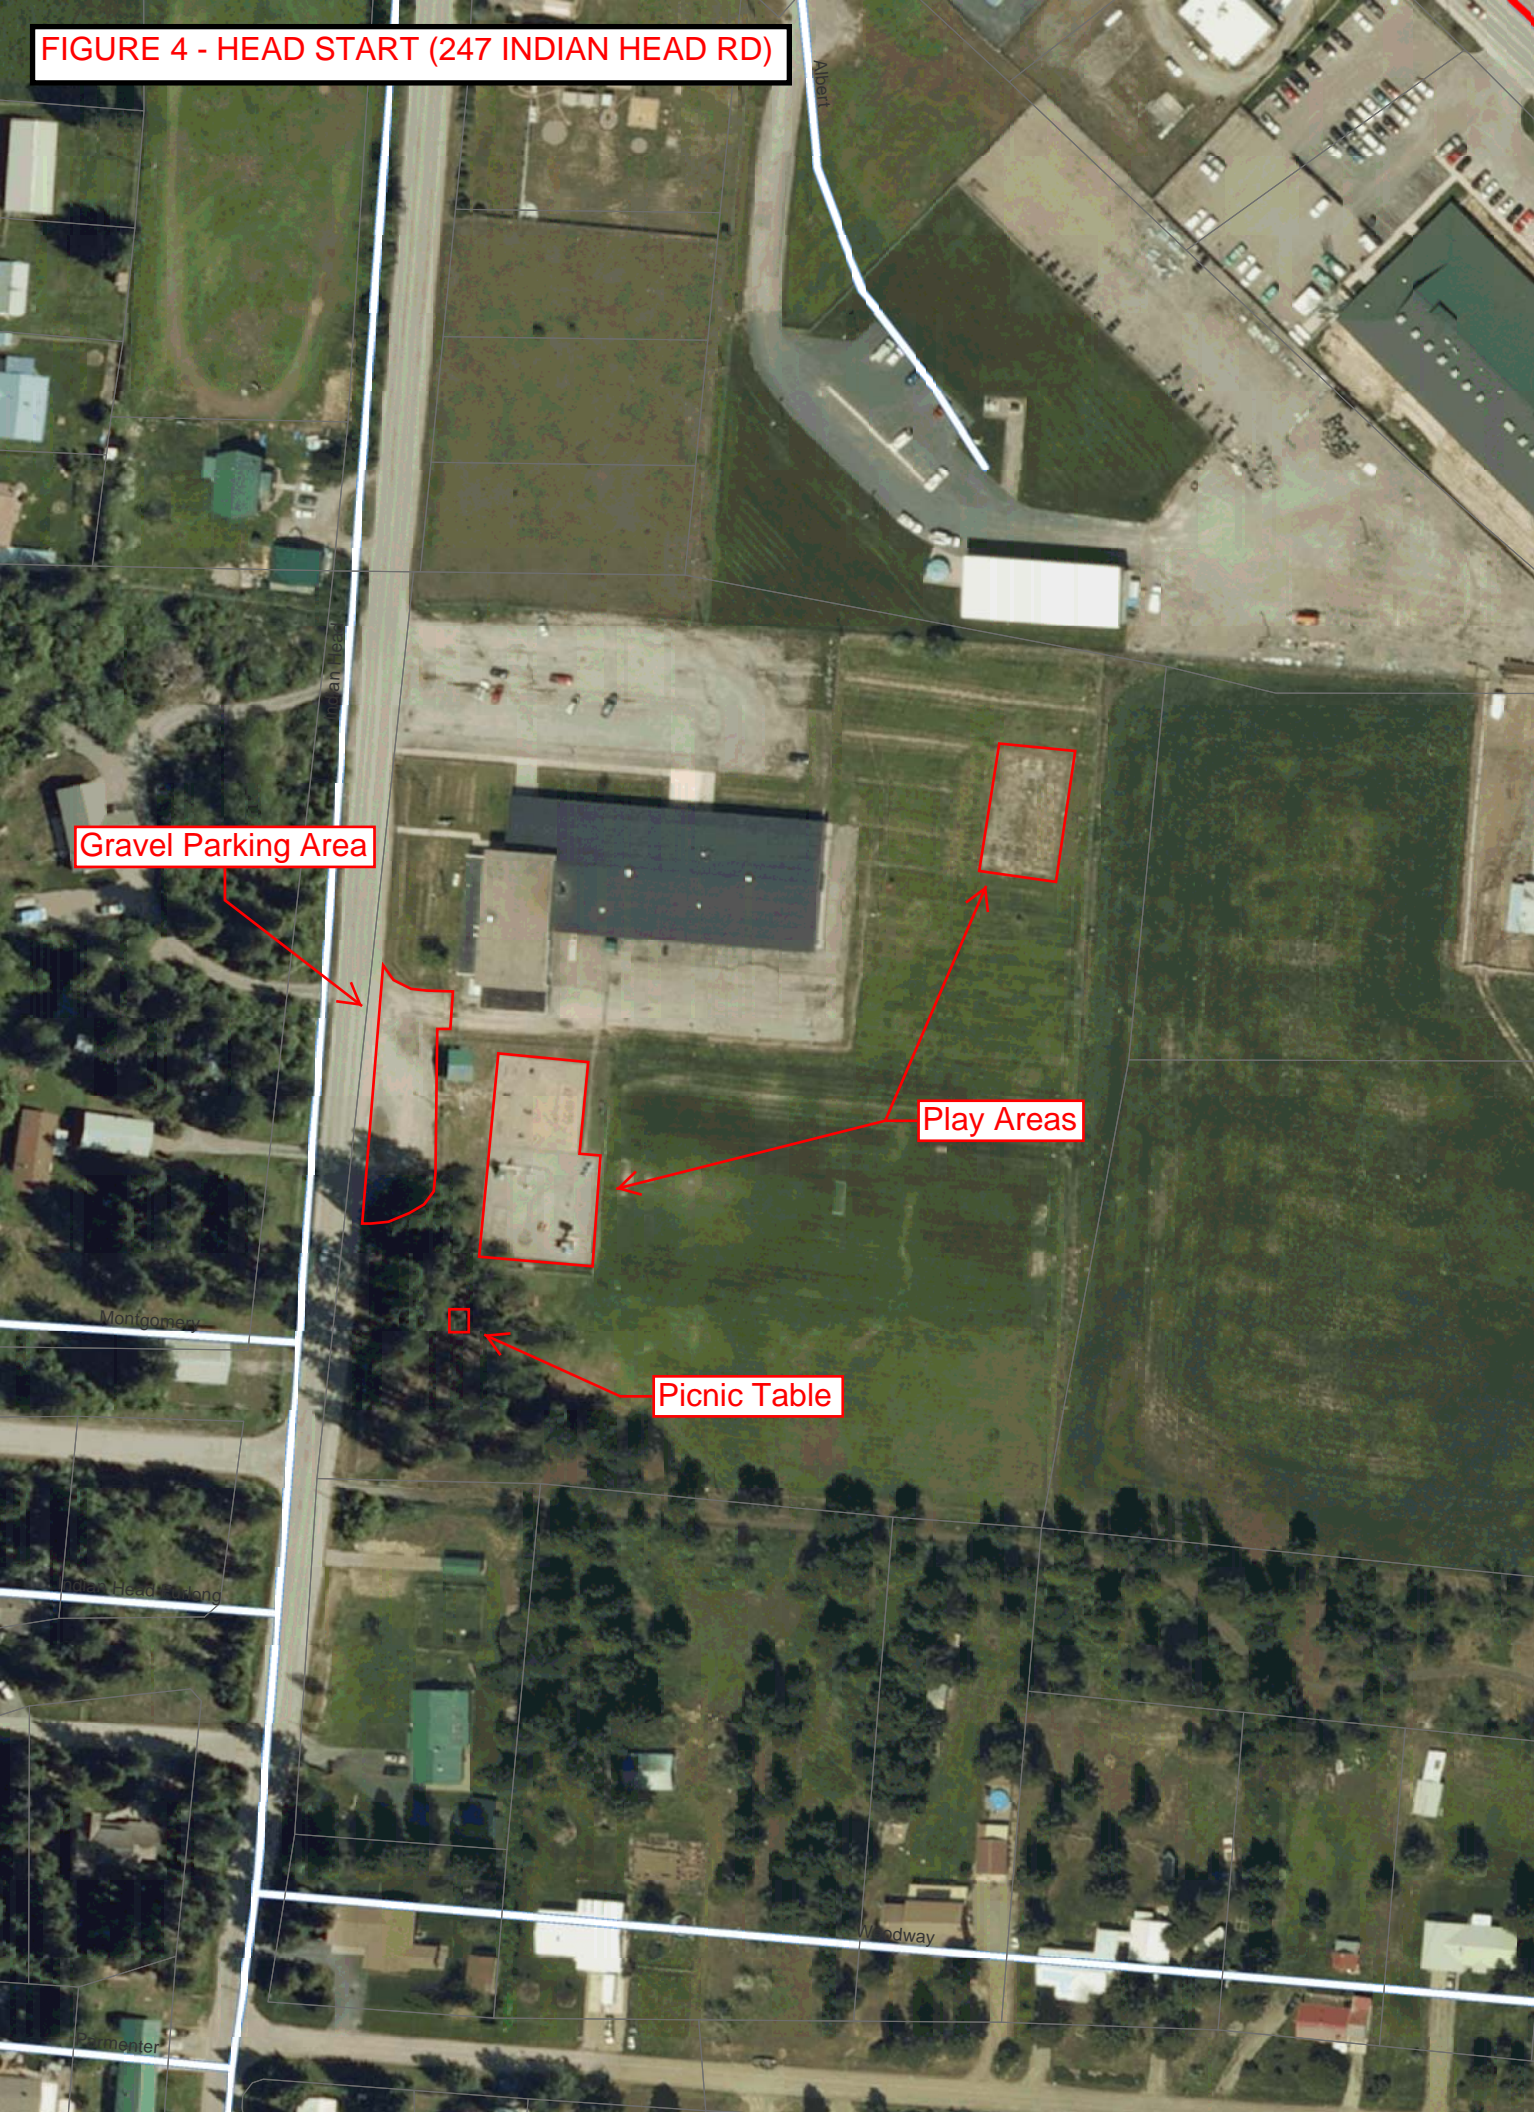
FIGURE 4 - HEAD START (247 INDIAN HEAD RD)

Gravel Parking Area

Play Areas

Picnic Table

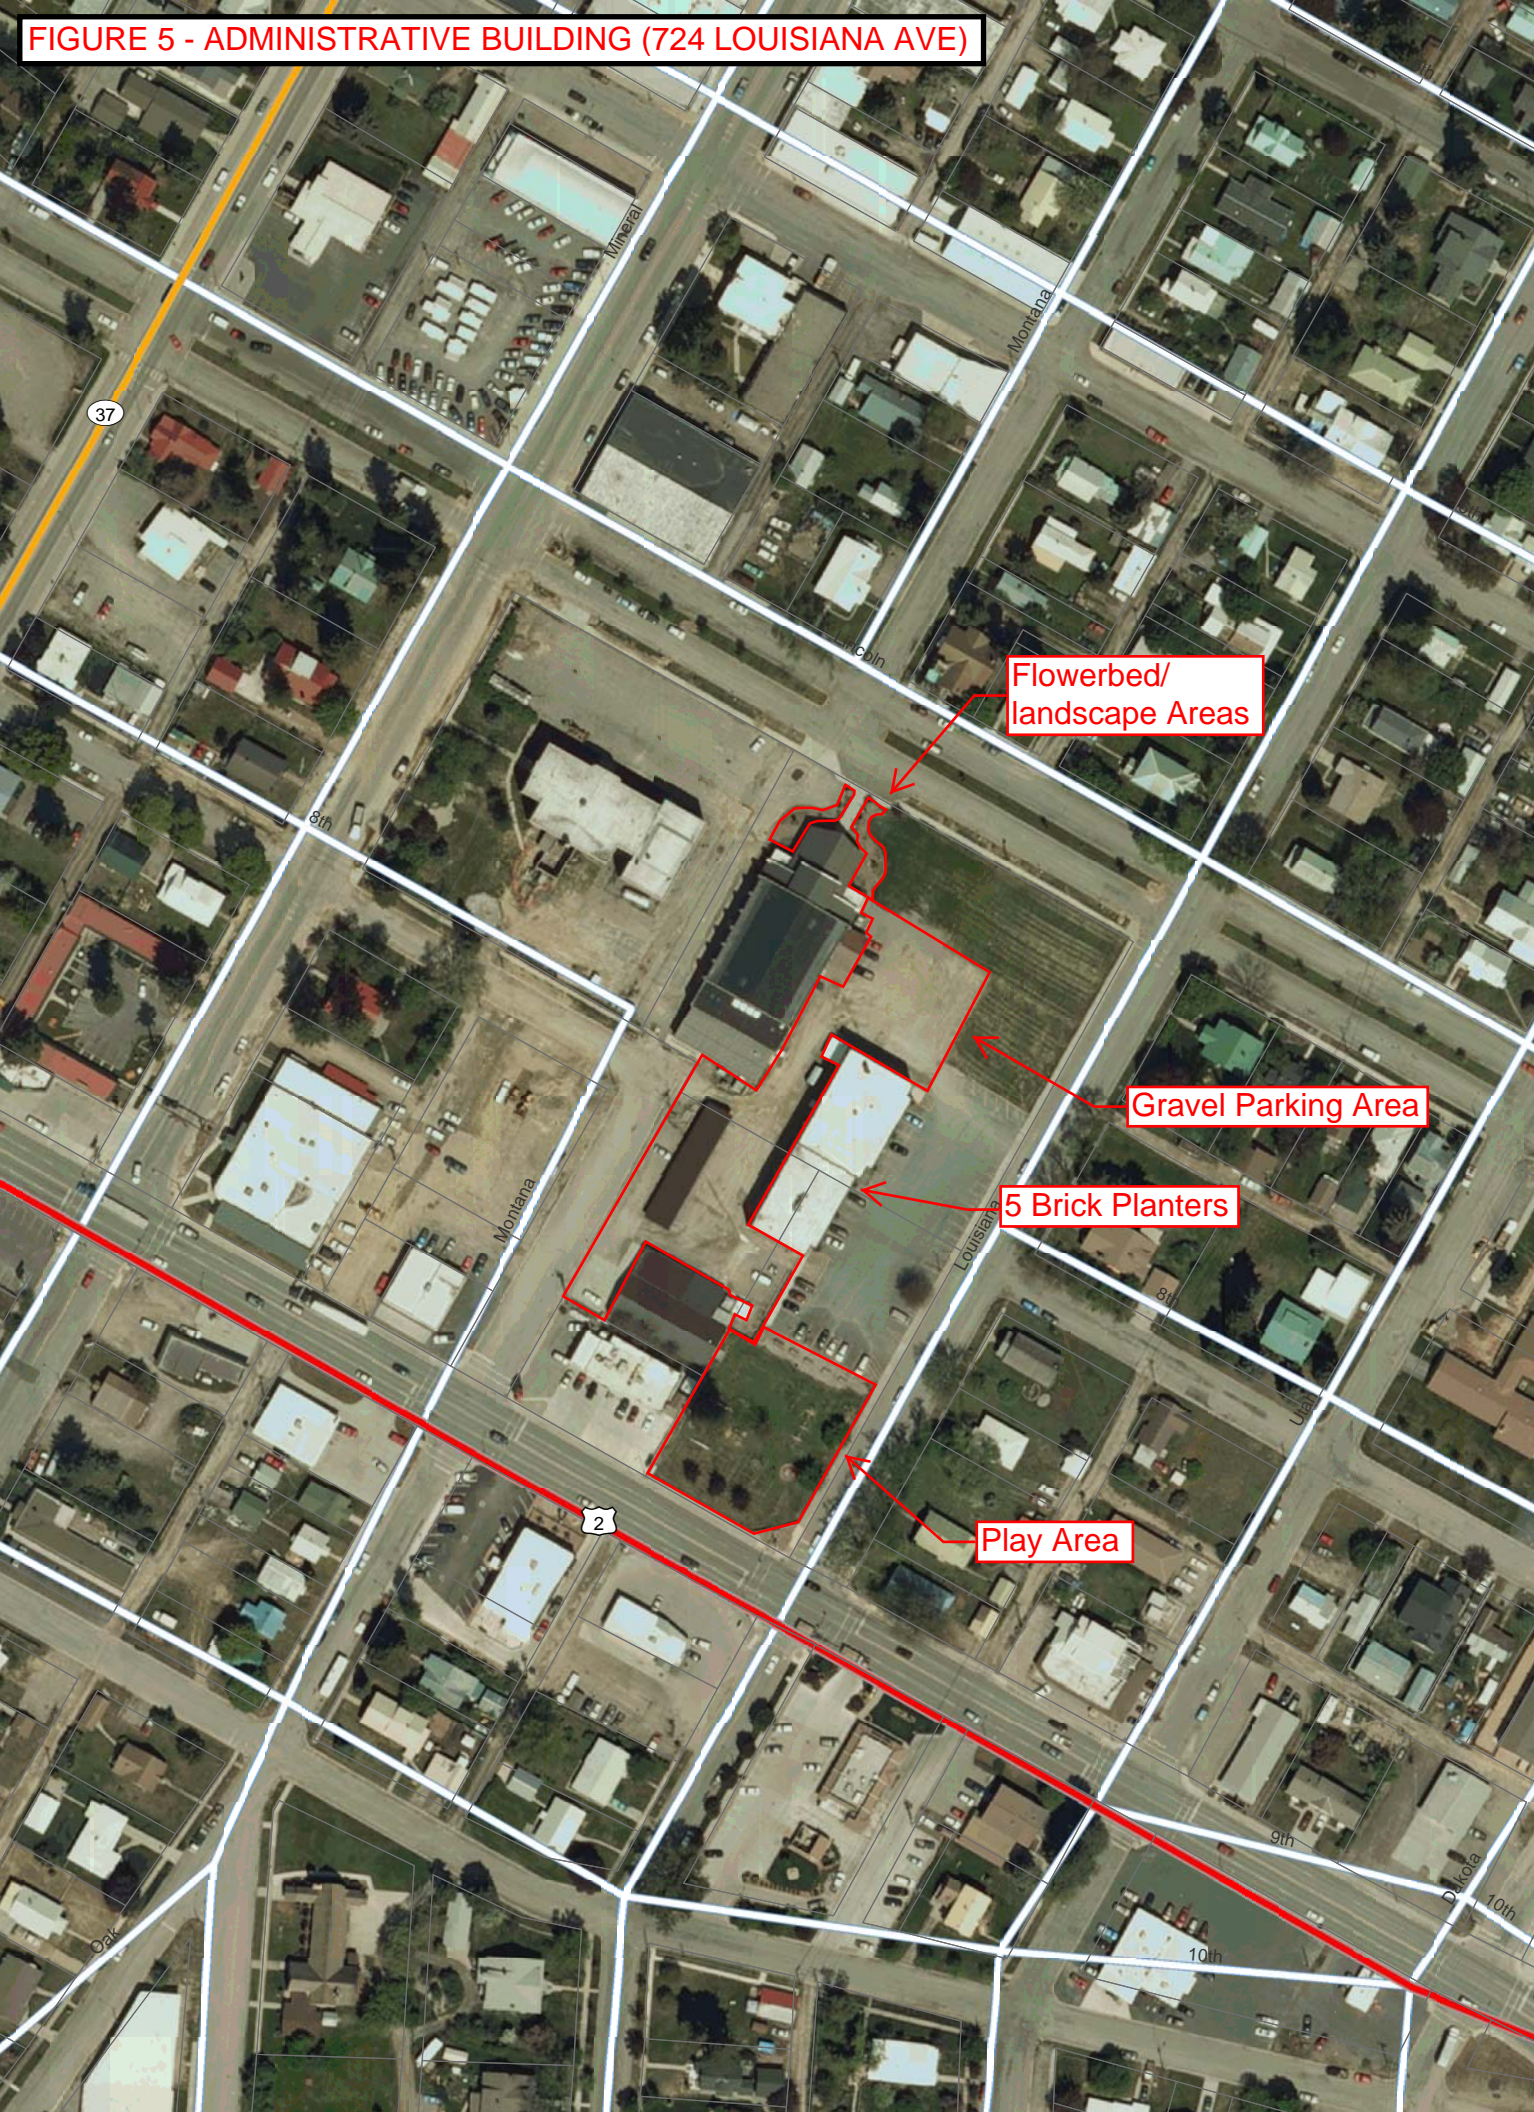
FIGURE 5 - ADMINISTRATIVE BUILDING (724 LOUISIANA AVE)

Flowerbed/  
landscape Areas

Gravel Parking Area

5 Brick Planters

Play Area
